# ADA Transition Plan

Final Plan Adopted November 2004

Addendum #1 Adopted December 2008

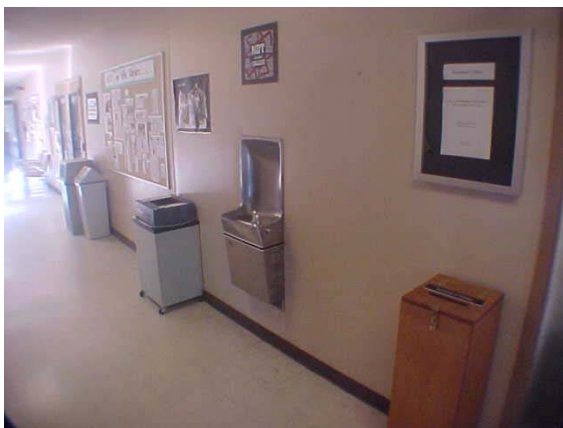
| <i>Number</i> | <i>Barrier Description</i> | <i>Building</i> | <i>Recommended Solution</i> | <i>Status</i> | <i>Comments</i> |
|---|---|---|---|---|---|
| 1.15 | Drinking Fountain near Administration is not accessible | 1300 | Replace with Accessible Hi-Lo Drinking Fountain | Completed | |

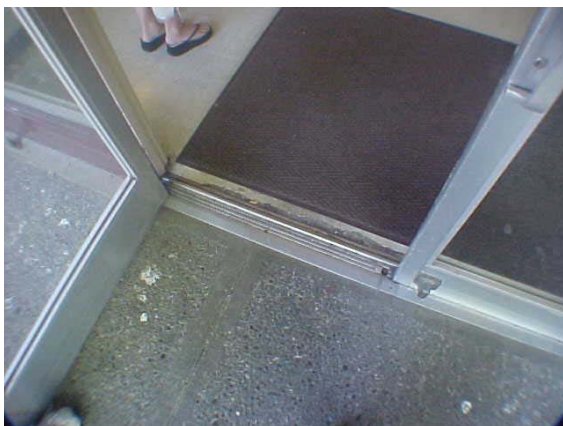
| <b>1.17</b> | <b>Main Building Entry</b> | <b>Problem:</b><br>At the main entry/exit doors (with power-assisted opener) the floor tile is damaged, creating an uneven surface just inside the door.<br><br><b>Solution:</b><br>Replace or patch the floor tile where damaged.<br><br><b>Cost:</b><br>Allowance to path floor <b>\$250</b> | <b>1.17</b> |

| <i>Number</i> | <i>Barrier Description</i> | <i>Building</i> | <i>Recommended Solution</i> | <i>Status</i> | <i>Comments</i> |
|---|---|---|---|---|---|
| 1.17 | Floor Tile is damaged at the Main Entry, causing uneven surface at interior landing | 1300 | Replace Tile or Patch to create smooth surface | Completed | |

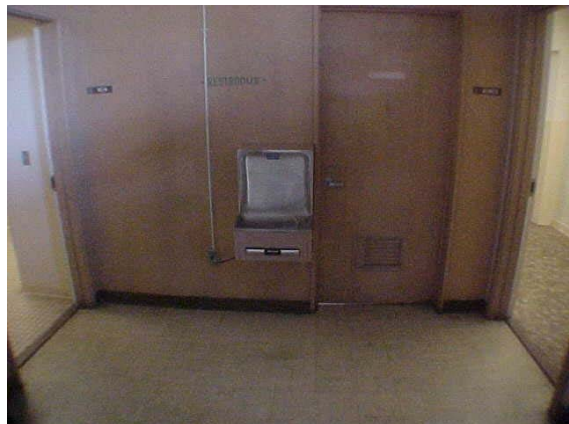
| <i>Number</i> | <i>Barrier Description</i> | <i>Building</i> | <i>Recommended Solution</i> | <i>Status</i> | <i>Comments</i> |
|---|---|---|---|---|---|
| 1.22 | The Drinking Fountain in the Lobby is not accessible, and not located in an alcove | 1500 | Replace with Accessible Hi-Lo Drinking Fountain | Completed | |

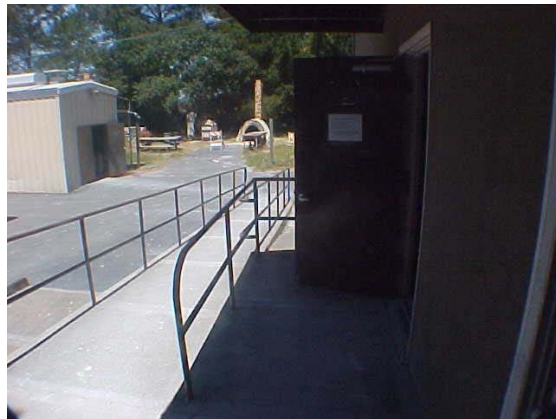
| <i>Number</i> | <i>Barrier Description</i> | <i>Building</i> | <i>Recommended Solution</i> | <i>Status</i> | <i>Comments</i> |
|---|---|---|---|---|---|
| 1.28 | Entry Door Kick Doorstop at Main Entry Doors interferes with bottom 10" of door | 3700 | Remove and Replace Doorstop | Completed | |

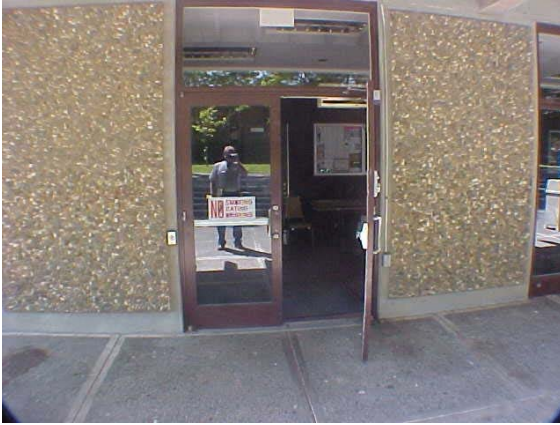
| <b>1.38</b> | <b>Main Entry</b> | <p><b>Problem:</b><br/>Doors must open a minimum of 90 degrees. The door with the power-assist opener only opens to +/-70 degrees.</p> <p><b>Solution:</b><br/>Adjust, repair or replace power-assist opener to allow to door to open 90 degrees.</p> <p><b>Cost:</b><br/>Budget <b>\$500</b> for repair</p> | <b>1.38</b> |

| <i>Number</i> | <i>Barrier Description</i> | <i>Building</i> | <i>Recommended Solution</i> | <i>Status</i> | <i>Comments</i> |
|---|---|---|---|---|---|
| 1.38 | Main Entry Doors do not open the required 90 degrees | 1200 | Adjust or Repair Openers to open door a minimum of 90 degrees | Completed | |

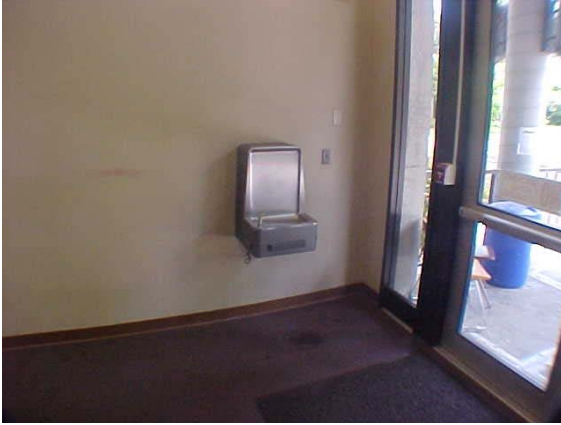
| <i>Number</i> | <i>Barrier Description</i> | <i>Building</i> | <i>Recommended Solution</i> | <i>Status</i> | <i>Comments</i> |
|---|---|---|---|---|---|
| 1.49 | The Drinking Fountain in the Lobby is not accessible, and not located in an alcove | 800 | Replace with Accessible Drinking Fountain | Completed | |

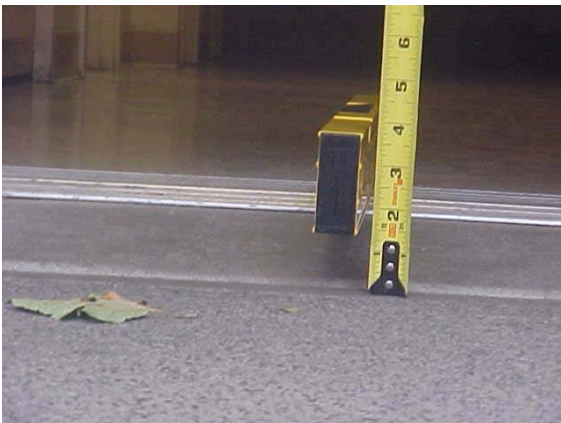
| <i>Number</i> | <i>Barrier Description</i> | <i>Building</i> | <i>Recommended Solution</i> | <i>Status</i> | <i>Comments</i> |
|---|---|---|---|---|---|
| 1.65 | Entrance to Director's Office - Landing offset is more than 1/2" below threshold | 3000 | Provide Ramp Threshold (T) | In Process | Permanent Solution may require re-grading and re-paving of landing to provide compliant condition |

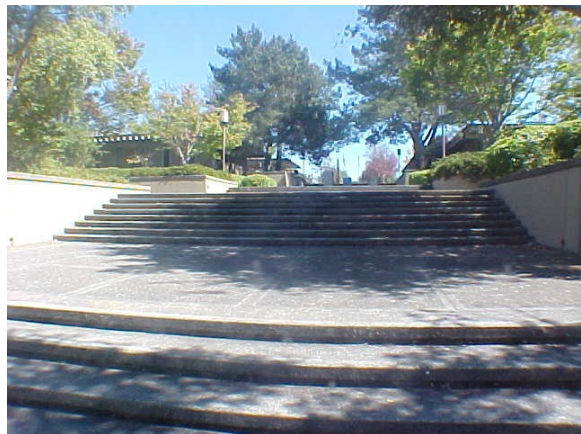
| <i>Number</i> | <i>Barrier Description</i> | <i>Building</i> | <i>Recommended Solution</i> | <i>Status</i> | <i>Comments</i> |
|---|---|---|---|---|---|
| 1.72 | Exterior Stairs (campuswide) do not have compliant handrails | n/a | Replace Handrails | Completed | |

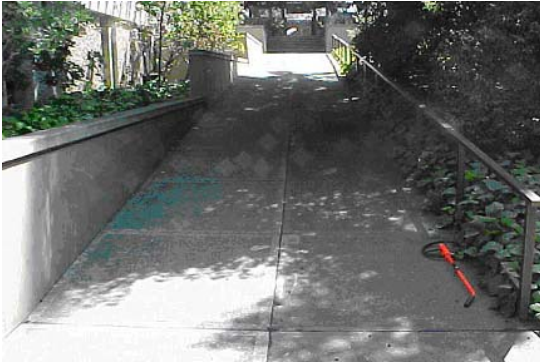
1.79

- o 1.79: Sloping Walkway from South Side of Building 800 to Pedestrian Mall – Non-compliant slope, handrails, vertical level change without landing(s)
- o 1.80: Replace Ramp at Replace Ramp and North of Building 800
- o 1.81: Replace Handrails North of Building 800

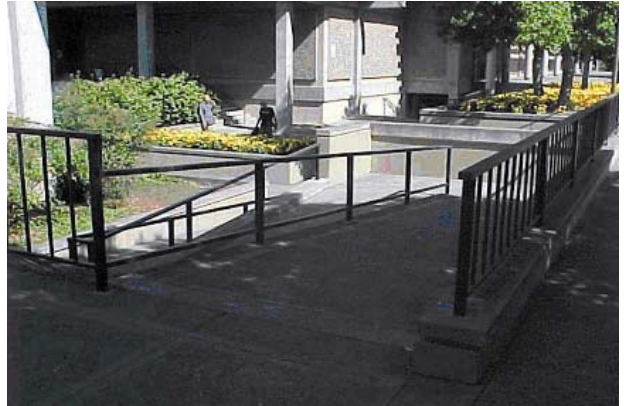
| <i>Number</i> | <i>Barrier Description</i> | <i>Building</i> | <i>Recommended Solution</i> | <i>Status</i> | <i>Comments</i> |
|---|---|---|---|---|---|
| 1.80 | Ramp at North Side of Building 800 - Non compliant slope, handrails, edge protection and landing size | n/a | Replace with Compliant Ramp | Deferred | Signage added to direct to nearest compliant ramp. Completion deferred to time with full building renovation. |

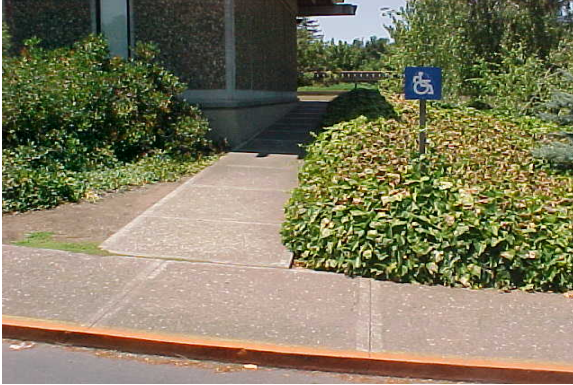
2.1

| Item No. | Item / Location | Description | Photo |
|---|---|---|---|
| <b>2.1</b> | <b>Path of travel from main parking lot to bldg. 300 entry</b> | <p><b>Problem:</b><br/>This is the accessible path of travel to the main entrance of building 300. The slope in the direction of travel is +/-5.7% with cross slope up to 3.4%.</p> <p><b>Solution:</b><br/>The walkway should be replaced during the building modernization to maintain a cross slope of 2%. Also, another path of travel to the building entry should be developed from the "Mall".</p> | <b>2.1</b> |

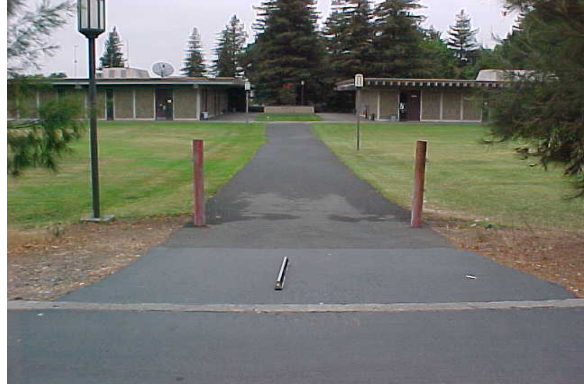
2.2

| Item No. | Item / Location | Description | Photo |
|---|---|---|---|
| <b>2.2</b> | <b>Walkway from south parking to main campus at bldgs. 600 &amp; 700</b> | <p><b>Problem:</b><br/>The slope in the direction of travel exceeds 5%.</p> <p><b>Solution:</b><br/>Replace the walkway. Import base and level the areas to reduce the slope of the walkway to 5% maximum. This work should be done with the first Bond Project in this area.</p> | <b>2.2</b> |

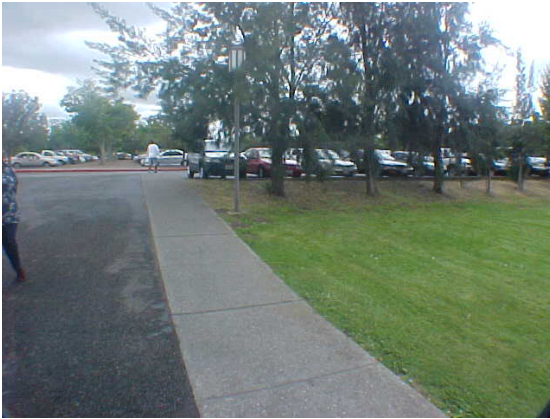
2.3

| Item No. | Item / Location | Description | Photo |
|---|---|---|---|
| <b>2.3</b> | <b>Walkway from south parking to main campus at the "Mall".</b> | <p><b>Problem:</b><br/>The slope in the direction of travel exceeds 5% in the direction of travel.</p> <p><b>Solution:</b><br/>Replace the walkway. Import base and level the areas to reduce the slope of the walkway to 5% maximum. This work should be done with the first Bond Project in this area.</p> | <b>2.3</b> |

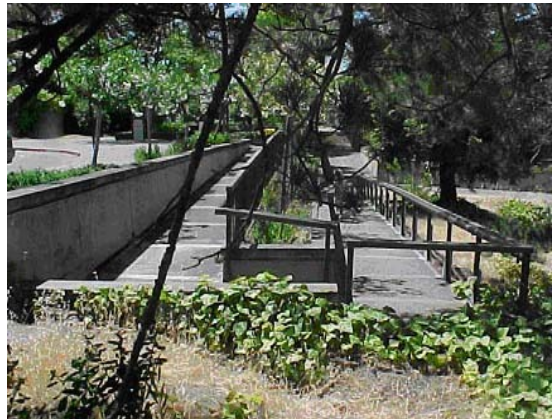
| 2.6 | Ramp to Tennis Courts and Fields at North end of Building 1100 | <b>Problem:</b><br>The slope at the top and intermediate landing exceeds 2% and the handrails are not compliant.<br><br><b>Solution:</b><br>With the construction of the new performing arts building provide a new accessible path of travel to replace this ramp or replace the upper and intermediate landings and provide a new handrail at the existing ramp. | |

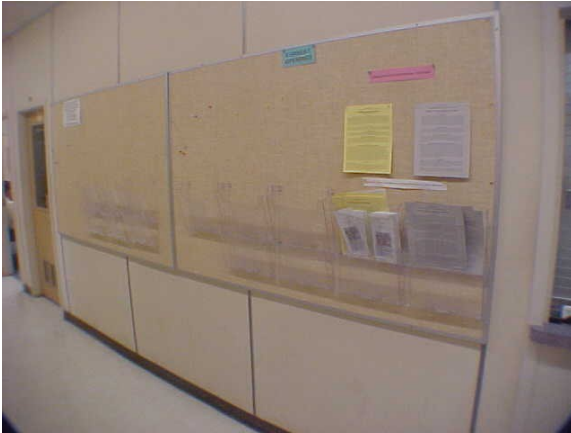
| <i>Number</i> | <i>Barrier Description</i> | <i>Building</i> | <i>Recommended Solution</i> | <i>Status</i> | <i>Comments</i> |
|---|---|---|---|---|---|
| 2.7 | Wall Trays for Handouts in Corridor project more than 4 inches from wall | 1300 | Remove or Replace Wall Trays | Deferred | Wall trays will be removed when the building is modernized |

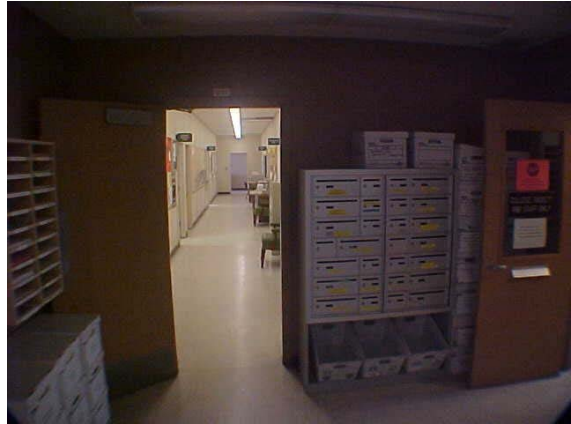
| <i>Number</i> | <i>Barrier Description</i> | <i>Building</i> | <i>Recommended Solution</i> | <i>Status</i> | <i>Comments</i> |
|---|---|---|---|---|---|
| 2.8 | Staff mailboxes project into clear space on strike side of door to Room 1337 | 1300 | Remove or Replace Mailboxes | Deferred | Mailboxes will be removed when the building is modernized |

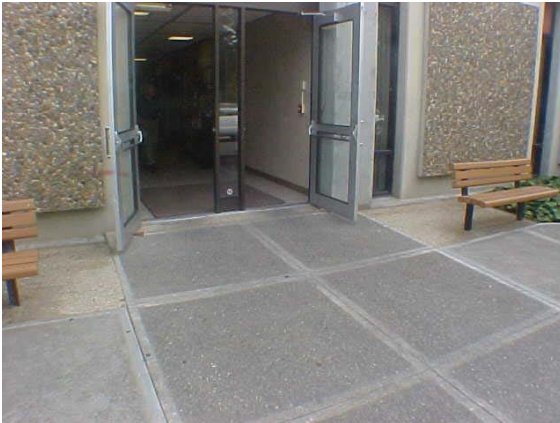
| <i>Number</i> | <i>Barrier Description</i> | <i>Building</i> | <i>Recommended Solution</i> | <i>Status</i> | <i>Comments</i> |
|---|---|---|---|---|---|
| 2.21 | West Entry Doors Landing - slope exceeds 2% | 1000 | Replace Walkway to provide a clear and level landing | Deferred | |

Replace the walkway in this area to provide a clear and level landing as required. This will be part of the building 1000B modernization.

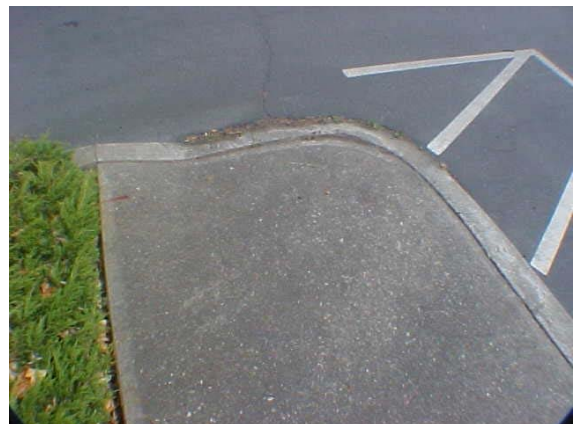
| <i>Number</i> | <i>Barrier Description</i> | <i>Building</i> | <i>Recommended Solution</i> | <i>Status</i> | <i>Comments</i> |
|---|---|---|---|---|---|
| 2.24 | Curb Ramp - slope is less than 6.67%, therefore requires detectable warnings | 3000 | Install Detectable Warnings or Replace with Compliant Curb Ramp | Deferred | |

Replace the curb cut so the slope in the direction of travel is between 6.67% and 8.33% to avoid the requirement of truncated domes.

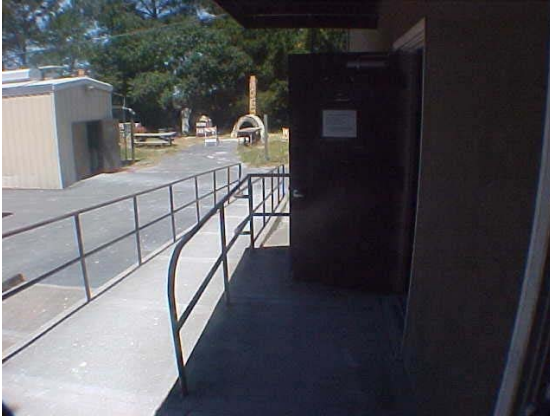
3.1

| Item No. | Item / Location | Description | Photo |
|---|---|---|---|
| <b>3.1</b> | <b>Door to Ceramics Classroom</b> | <p><b>Problem:</b><br/>A clear and level space in the direction of the door swing of a minimum 60" is required. The existing condition has a clear space of 53" in the direction of the door swing.</p> <p><b>Solution:</b><br/>Due to its configuration, the ramp leading to the ceramics classroom door will need to be replaced to provide the required clearance.</p> | <b>3.1</b> |

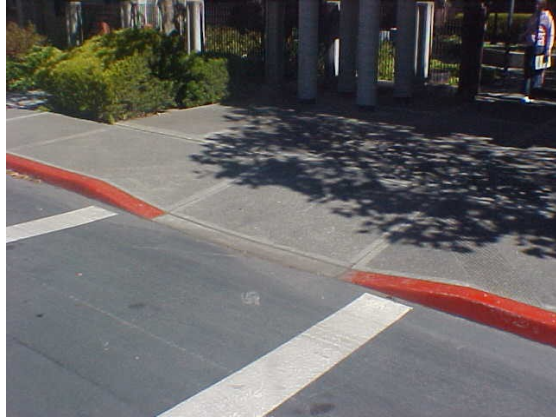
| Item No. | Item / Location | Description | Photo |
|---|---|---|---|
| <b>3.2</b> | <b>Curb Cut in front of Child Care</b> | <p><b>Problem:</b><br/>The slope in the direction of travel exceeds 8.33% (+/-11.2% actual).</p> <p><b>Solution:</b><br/>Replace curb cut.</p> | <b>3.2</b> |

| <i>Number</i> | <i>Barrier Description</i> | <i>Building</i> | <i>Recommended Solution</i> | <i>Status</i> | <i>Comments</i> |
|---|---|---|---|---|---|
| 3.2 | Curb Cut at Building 3000 - slope exceeds 8.33% | | Replace Curb Cut | Deferred | |
